# **CRITICAL AREAS REPORT AND DETAILED MITIGATION PLAN**

## **BUILDING X PROJECT REDMOND, WASHINGTON**

6 February 2019  
(Revised 18 October 2019)

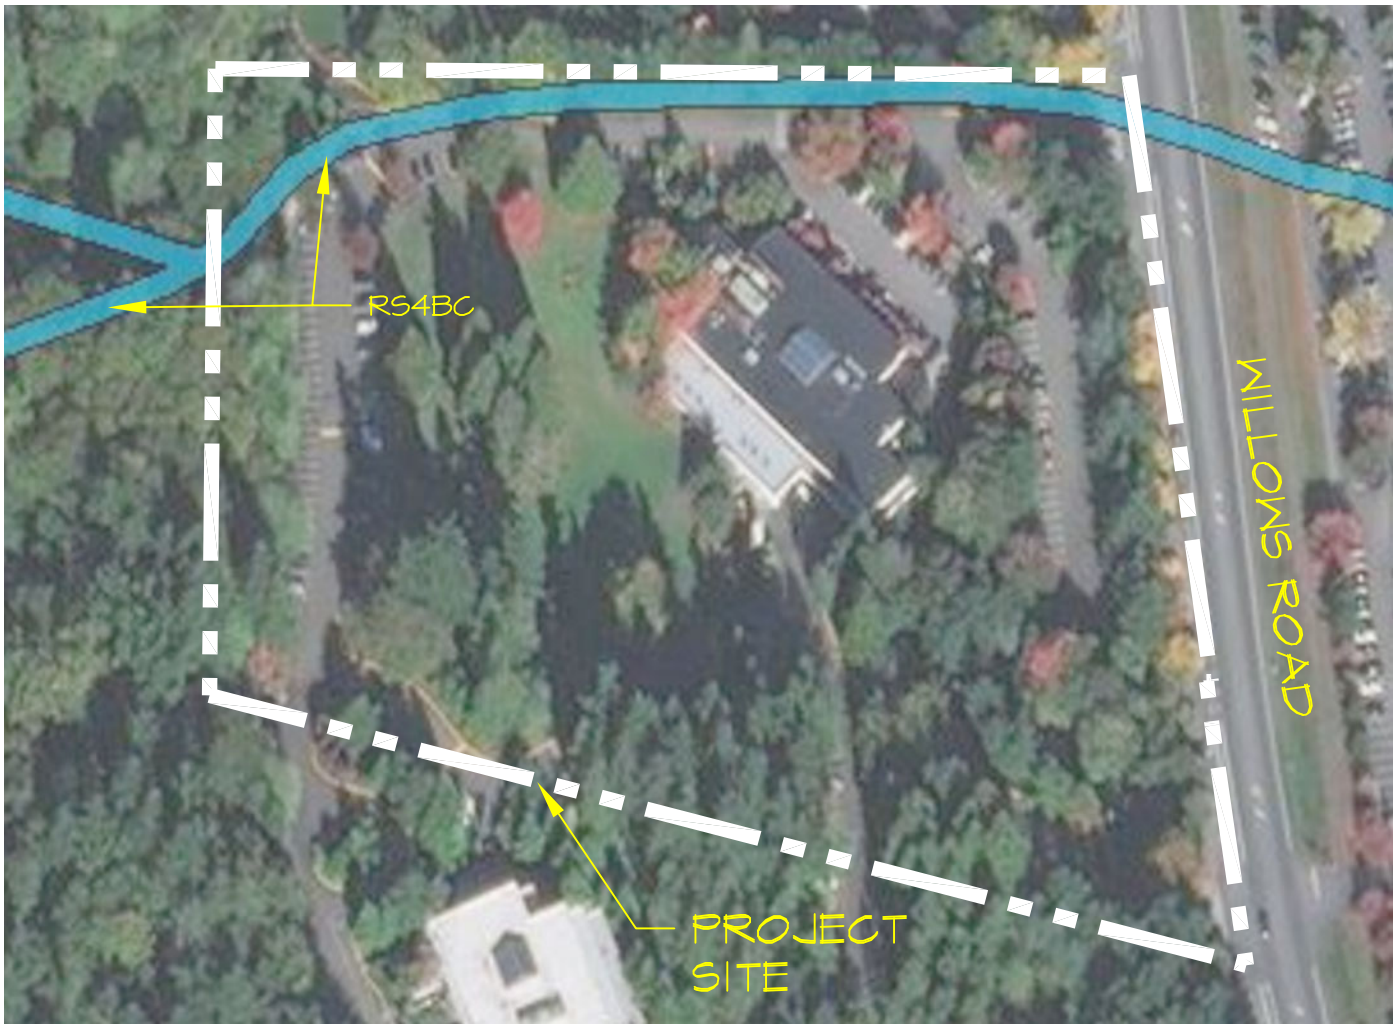
FIGURE #3

## LEGEND

TYPE	DESCRIPTION
RS4BC	RIVERINE, INTERMITTENT STREAMBED, SEASONALLY FLOODED.

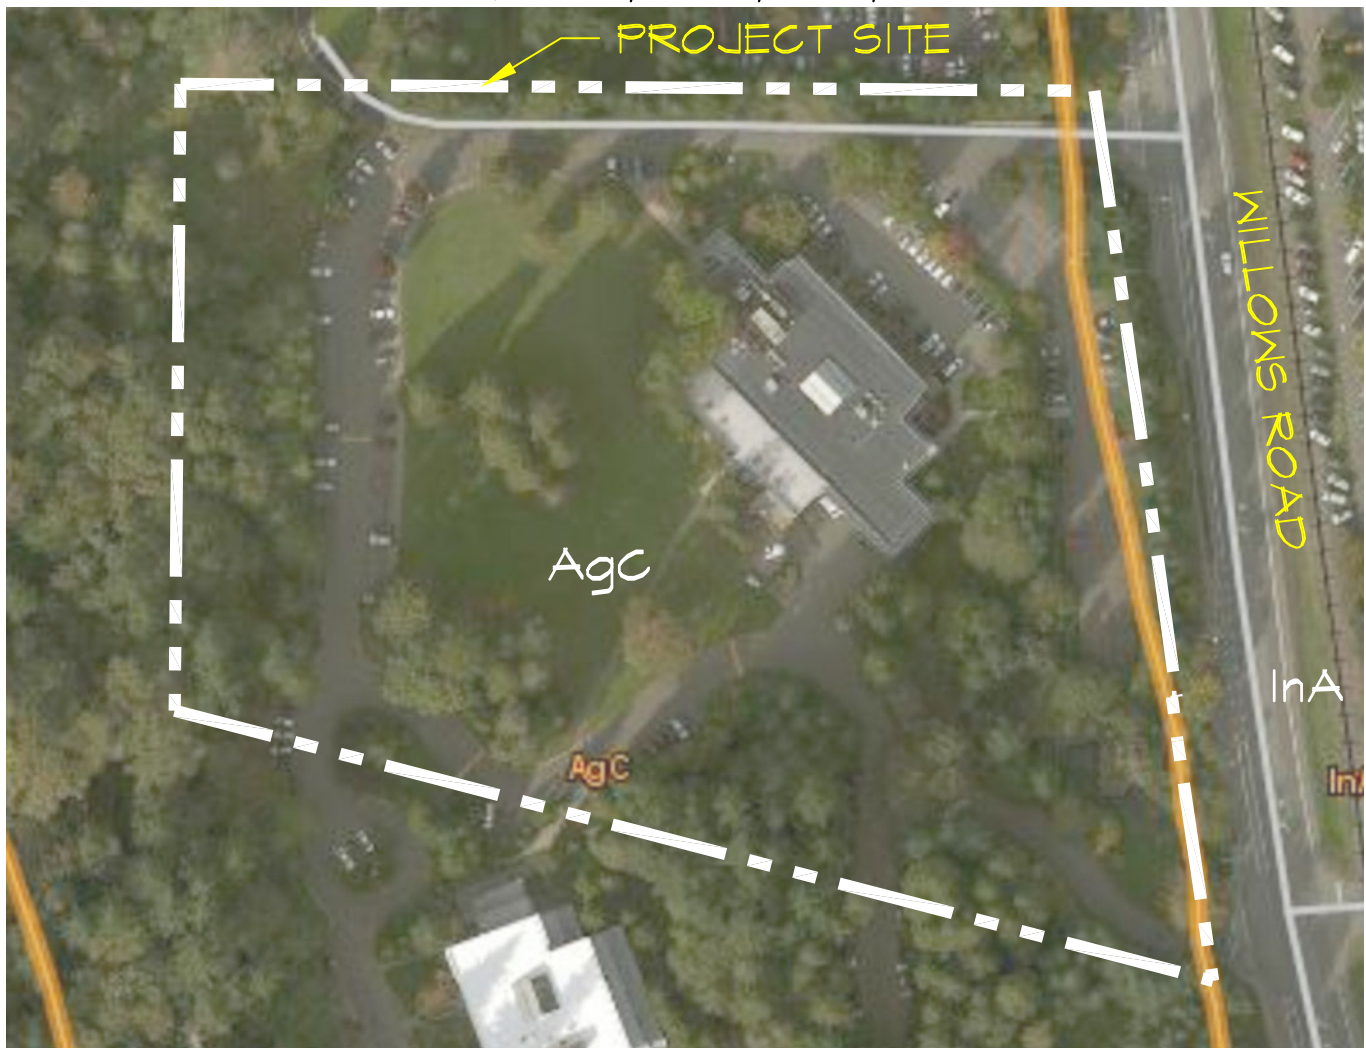
### FIGURE #4

## LEGEND

TYPE	DESCRIPTION, SLOPES
AgC	ALDERWOOD GRAVELLY SANDY LOAM, 8-15% SLOPES.
InA	INDIANOLA LOAMY SAND, 0-5% SLOPES.

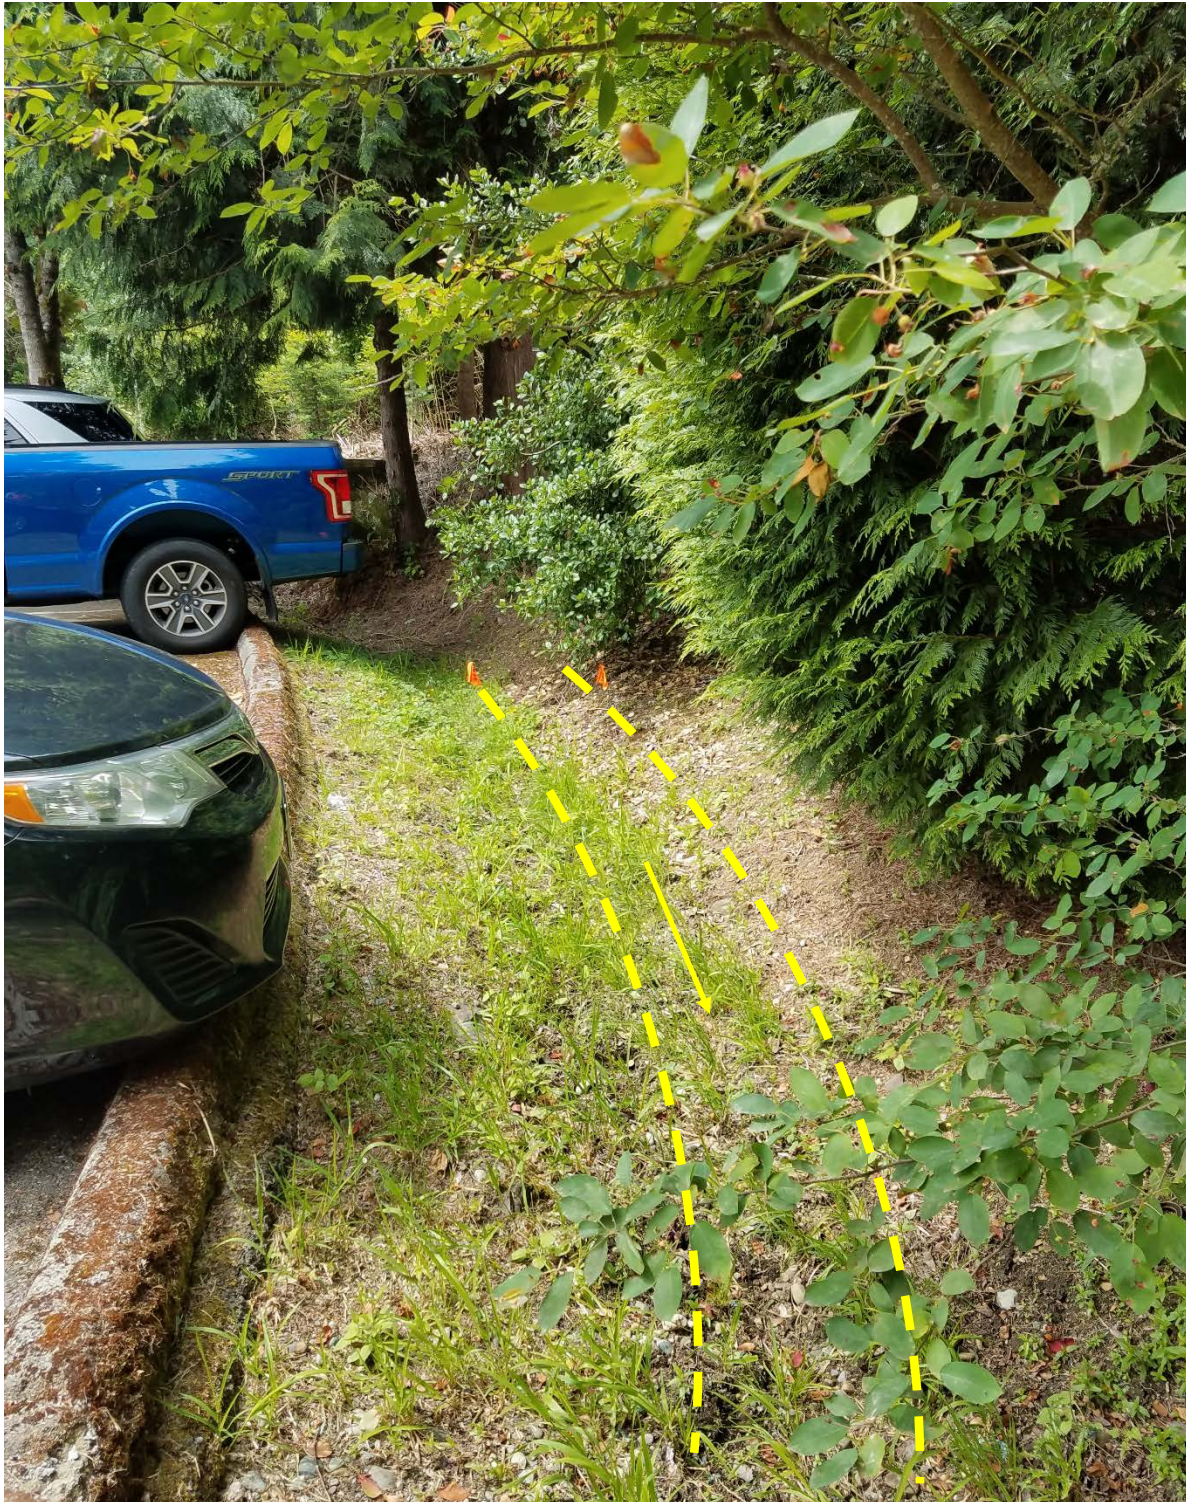
**Photo 1.** Stream 1 looking southwest from the northwest parking lot area on Parcel A. Orange pin-flags were used to delineate the OHWM (dashed yellow line). Photo date: 12 June 2018.

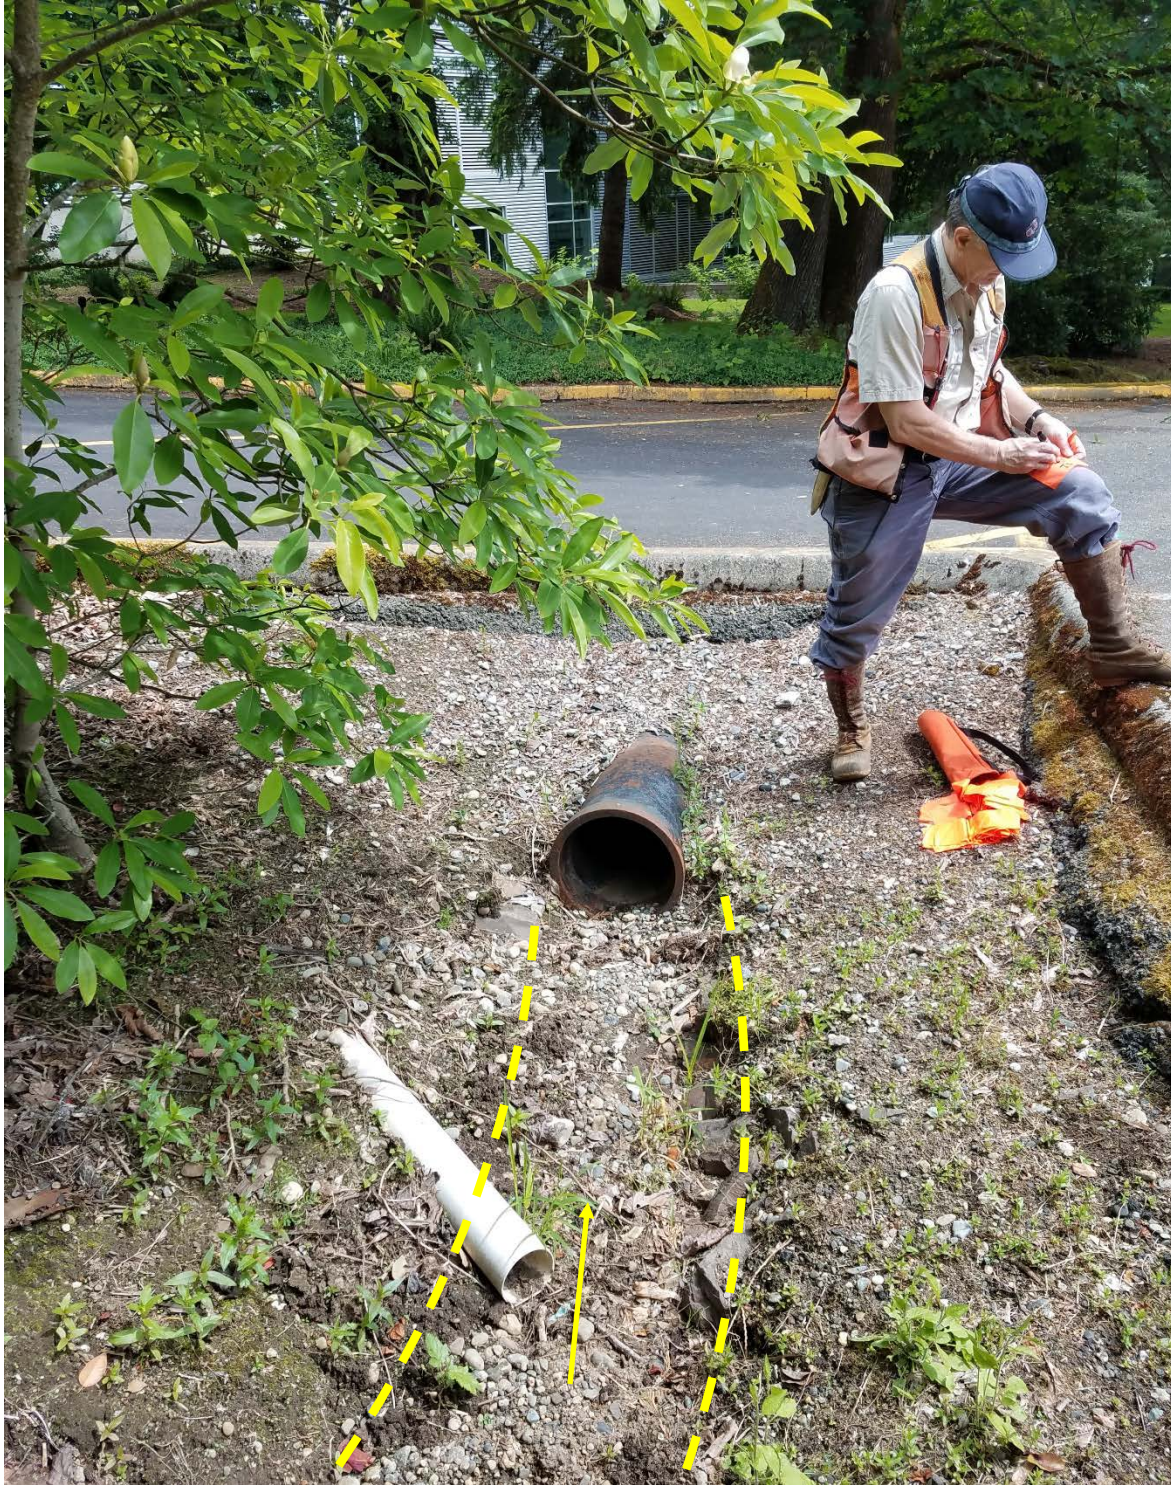
**Photo 2.** Stream 1 looking east northeast from the northwest parking lot area on Parcel A. This is the first culvert that Stream 1 passes through. The road bridging the culvert connects the parking lot of Parcel A with the adjacent property to the north. Photo date: 12 June 2018.

The existing stream channel is approximately 2 feet wide and flows through four culverts, one of which is under an existing access road to the property to the north. The remaining three culverts provide no function whatsoever. One of the unnecessary culverts cannot be removed. This culvert, which is east of the aforementioned access road, is currently entwined with the roots of a landmark big-leaf maple. The project arborist has determined that removing the culvert will likely damage the tree's roots and

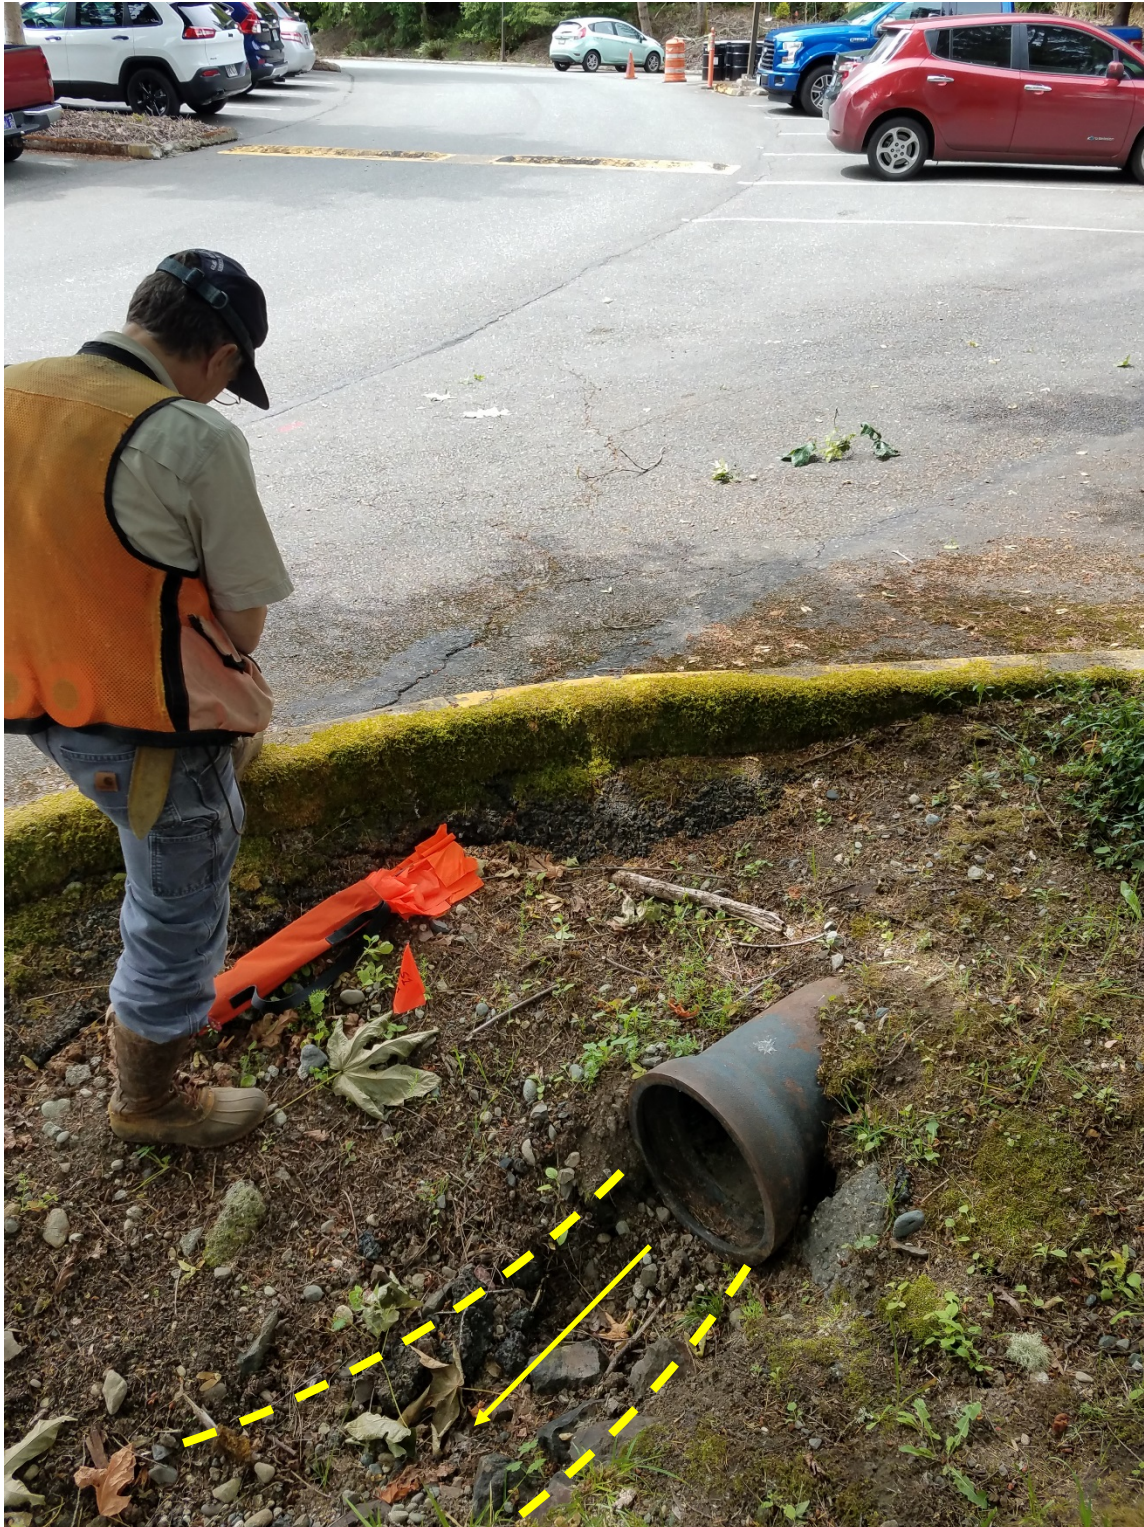
**Photo 3.** The outlet to the culvert in Figure 2, facing southwest. Photo date: 12 June 2018.

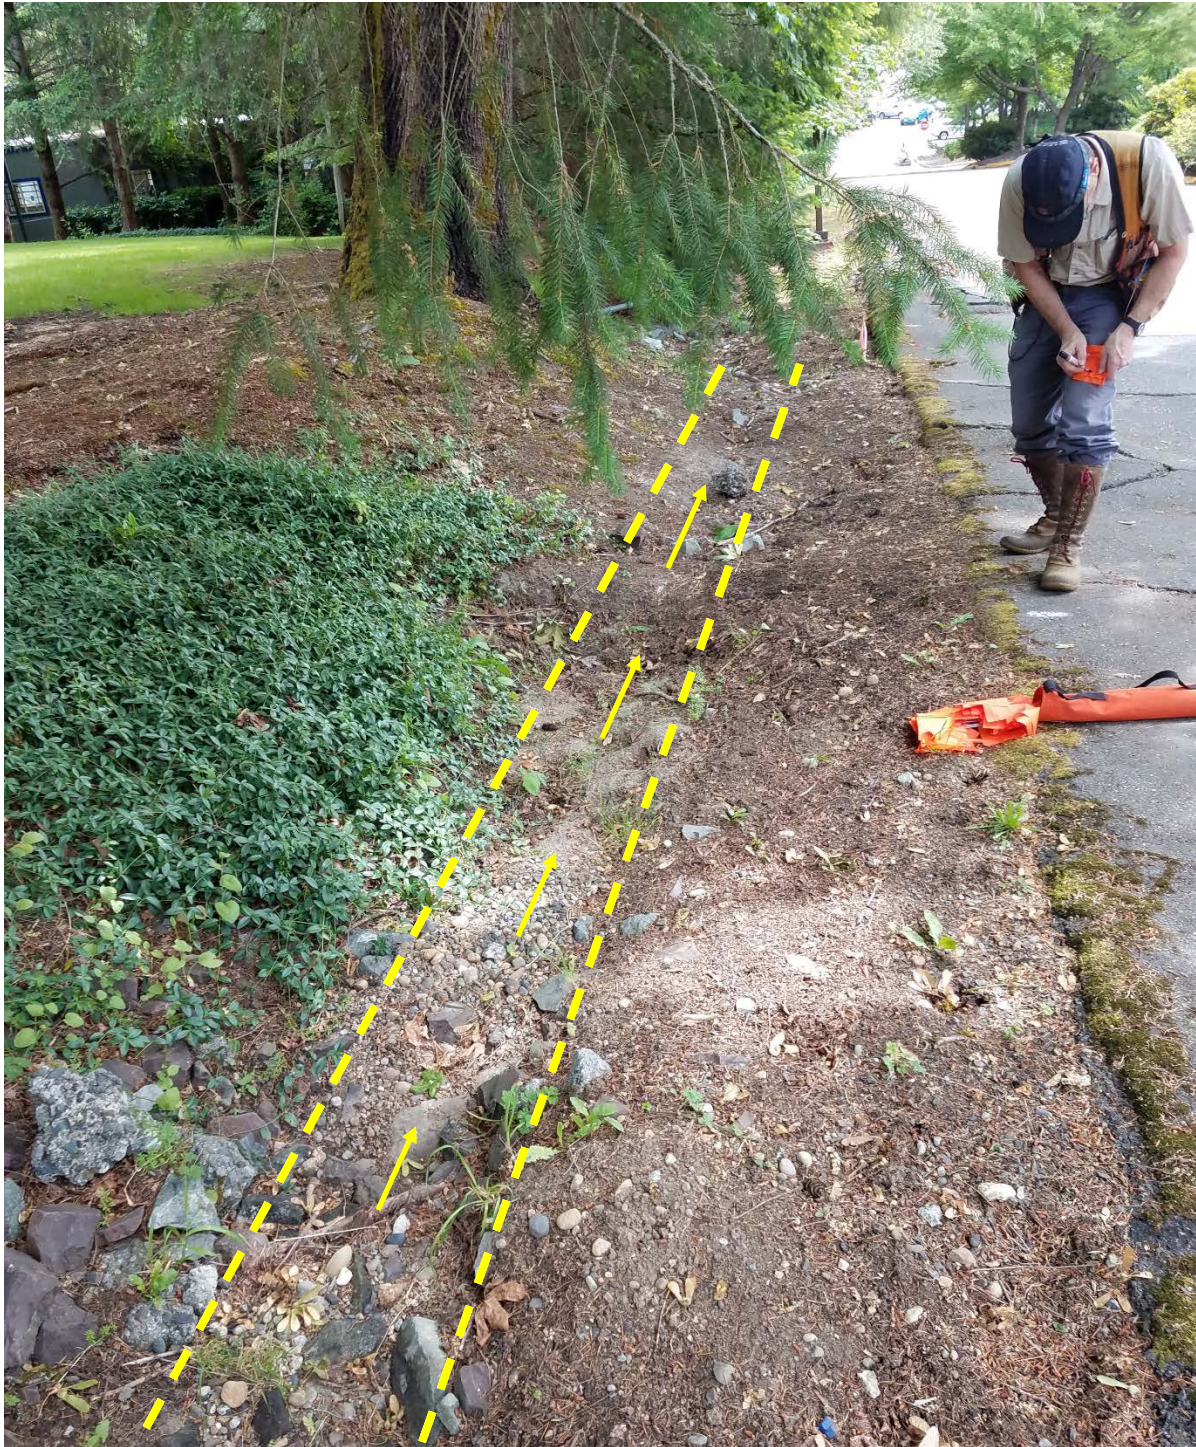
**Photo 4.** Stream 1 facing east from the outlet of the first culvert (Photo 3). The buffer of Stream 1 is mostly developed as Site access to the south and maintained as landscaping to the North. Photo date: 12 June 2018.

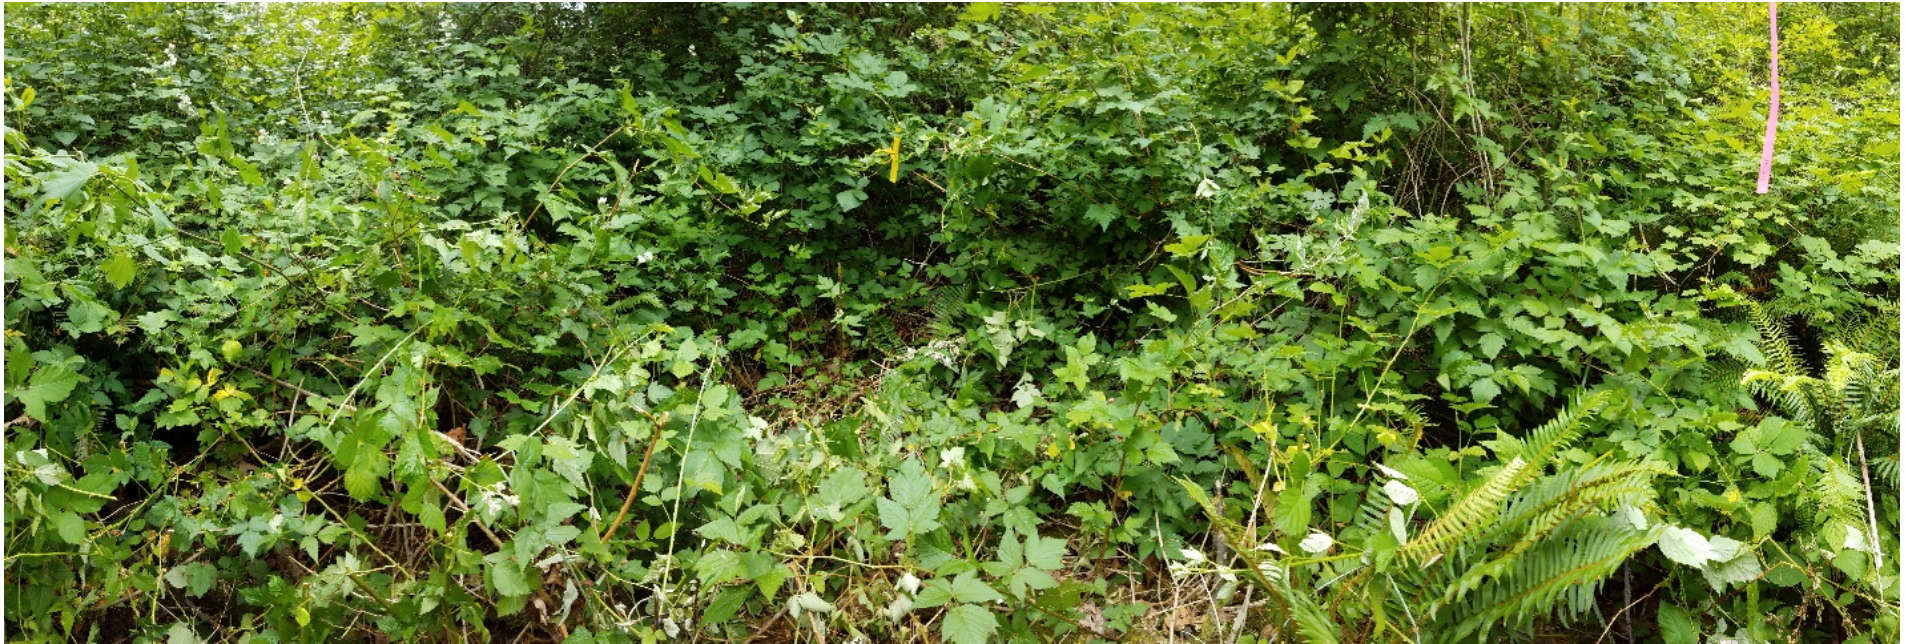
**Photo 5.** Sample Point TP-UPL-1 Typical Vegetation.

Photo date 22 June 2018. Vegetation includes sword fern, trailing blackberry, salmonberry, big-leave maple, and vine maple.

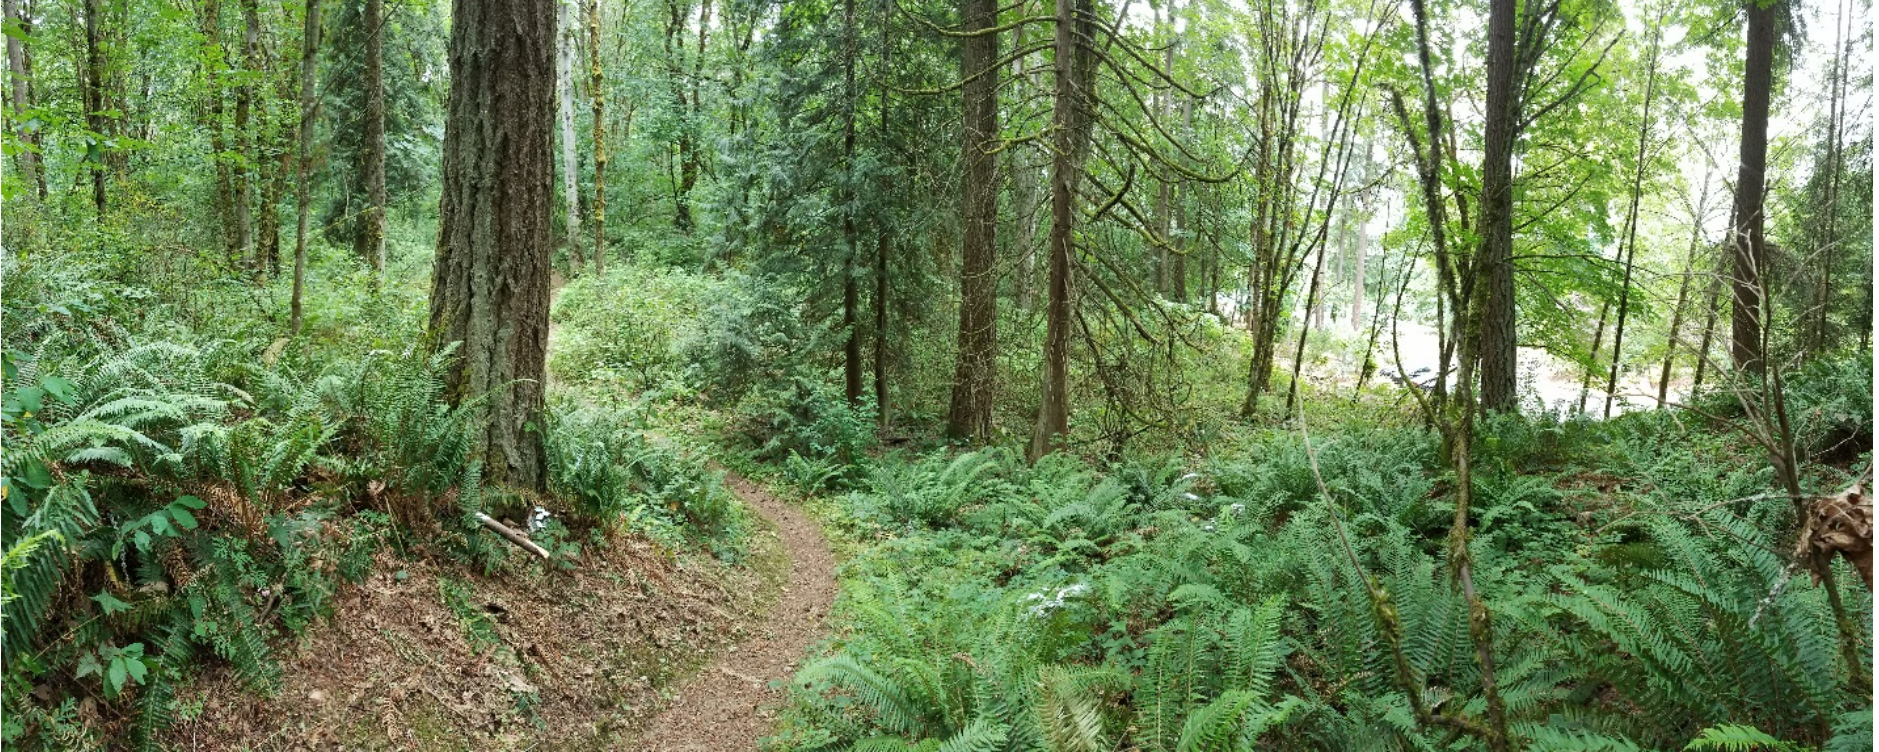
**Photo 6.** Photo of N/S oriented trail, west of developed Site area facing north towards TP-UPL-2 and TP-UPL-3 at property corner of Parcel A and Parcel B. Photo date 22 June 2018. Vegetation includes Douglas fir, sword fern, and Indian plum.

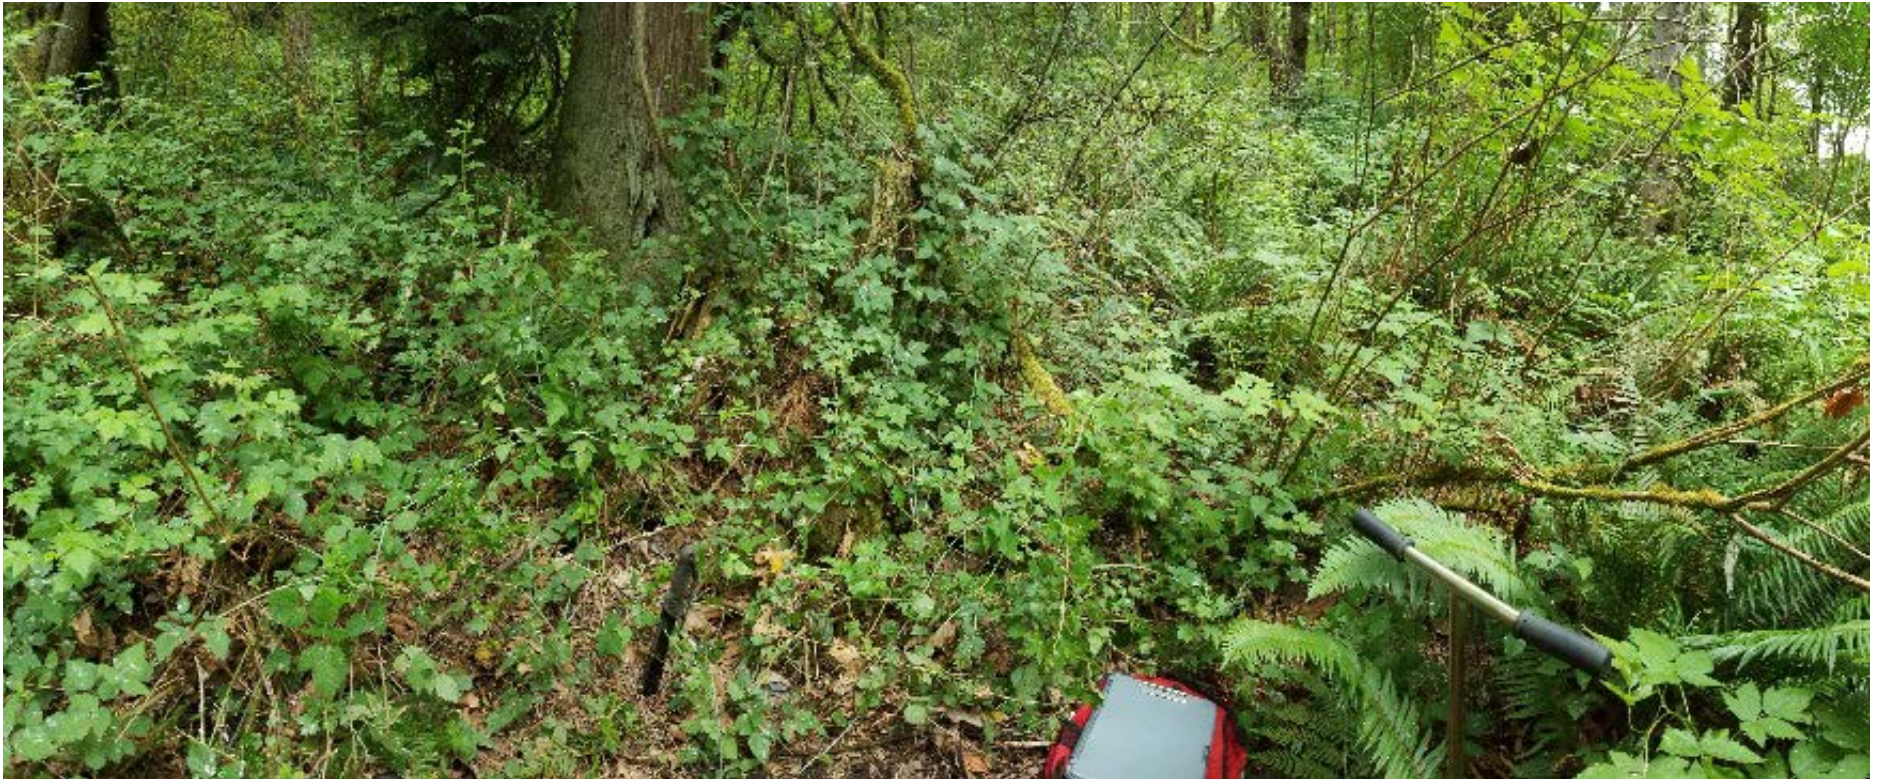
Photo 7. Sample Point TP-UPL-2 Typical Vegetation.

Photo date 22 June 2018. Vegetation includes western hemlock, vine maple, salmonberry, and sword fern.

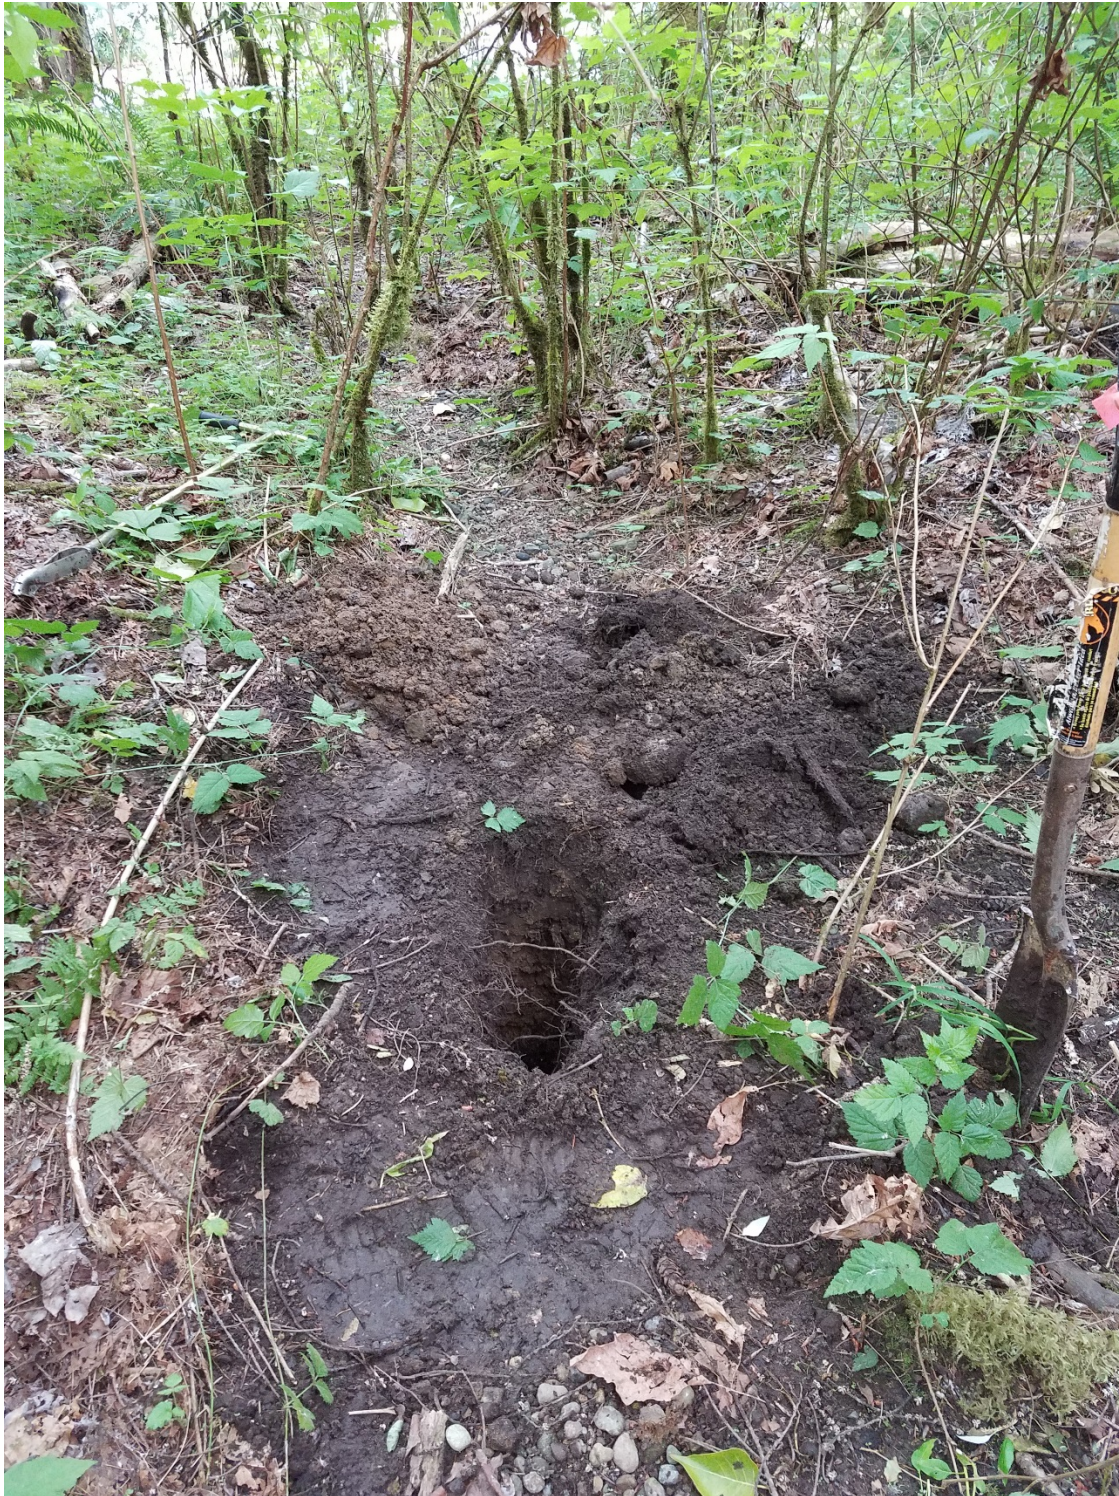
**Photo 8.** Sample Point TP-UPL-3. No hydrology (soil saturation or water table) present to within 20 inches of the soil surface.  
Photo date 22 June 2018.

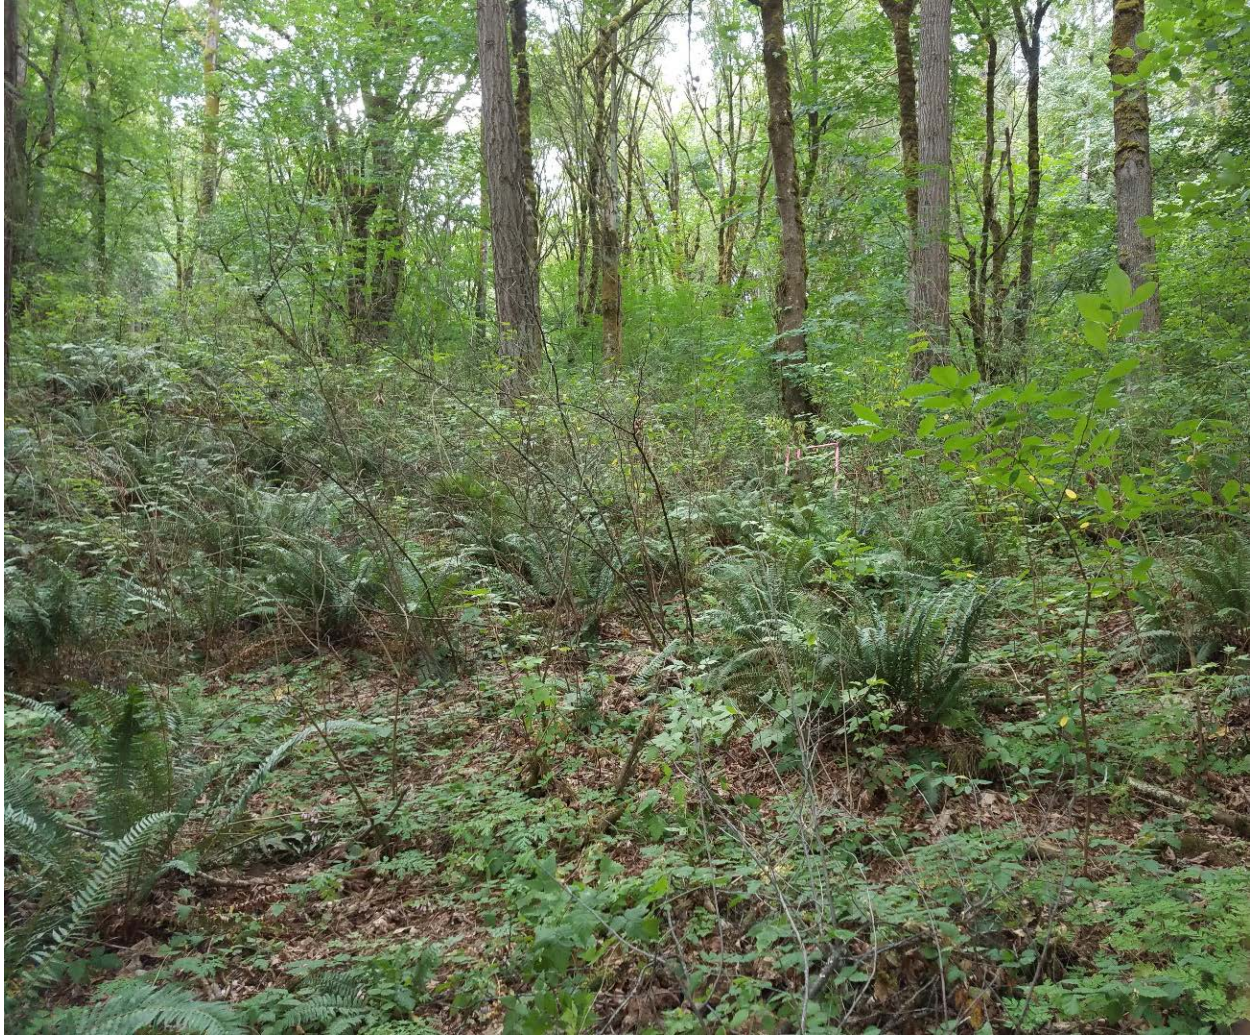
**Photo 9.** Representative vegetation in general area of TP-UPL-4. Vegetation includes Indian plum, trailing blackberry, herb Robert, sword fern, Douglas fir, and big-leaf maple. Photo date: 22 June 2018.

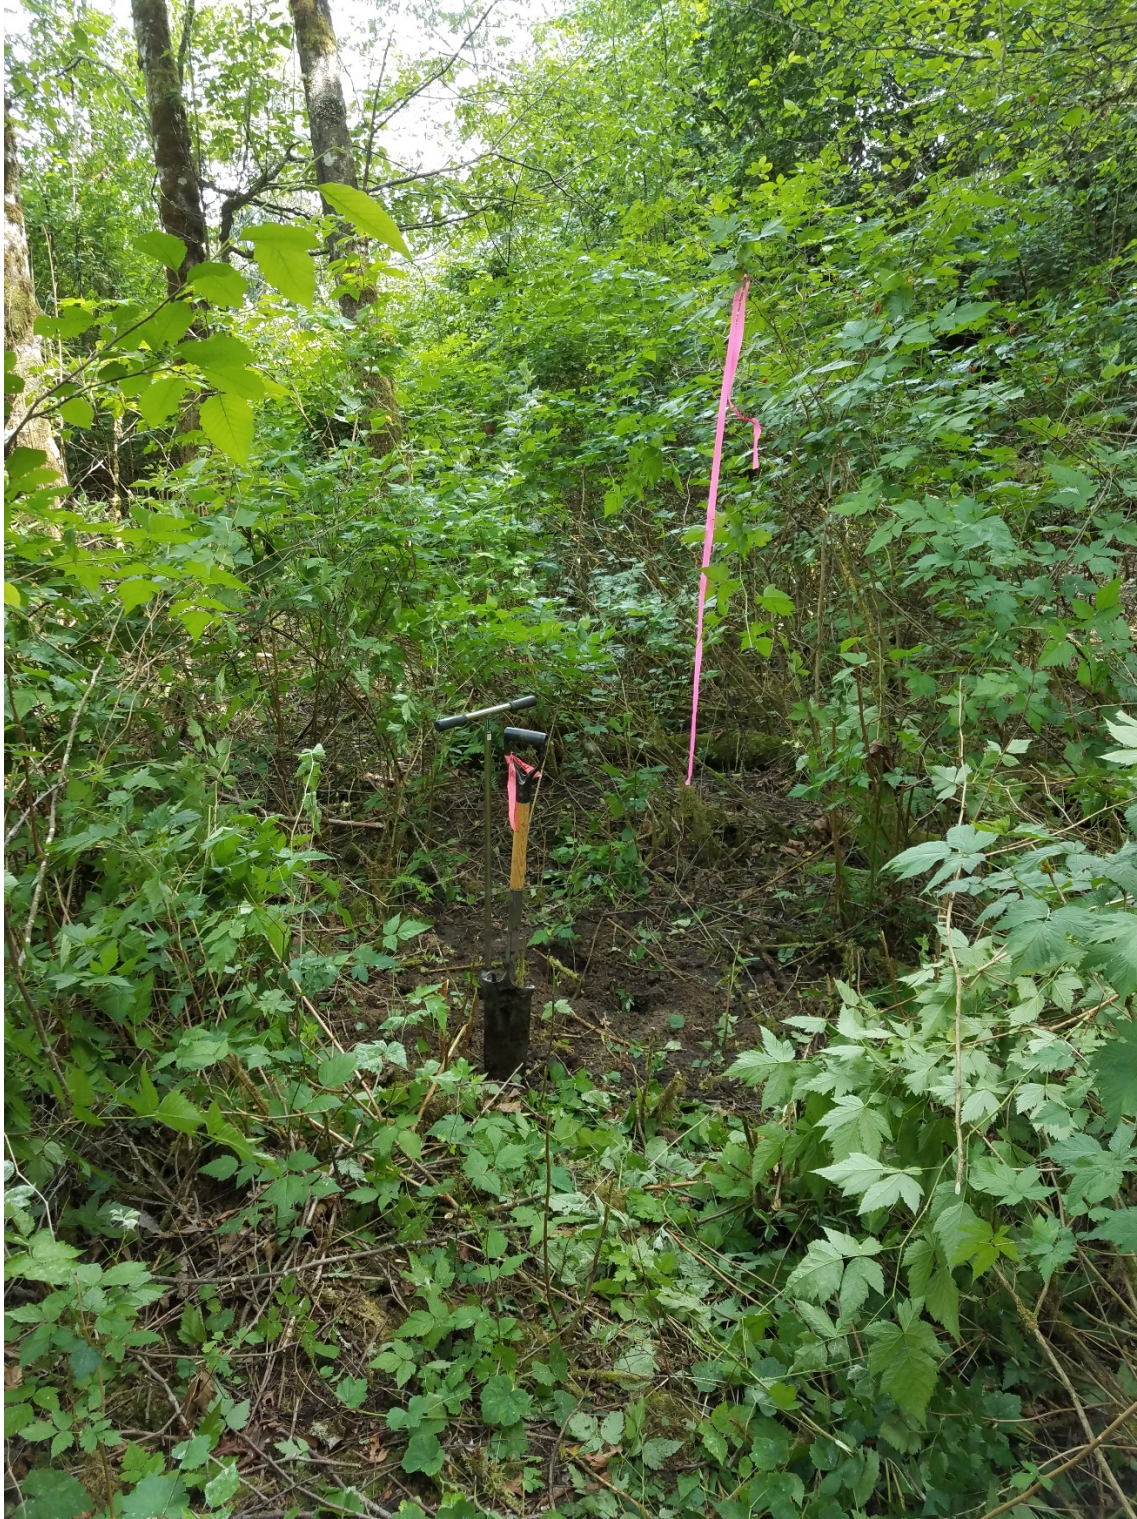
**Photo 10.** Sample Point TP-UPL-5 Typical Vegetation. Vegetation includes red alder, bitter cherry, salmonberry, and giant fringe cup. Photo date: 22 June 2018.

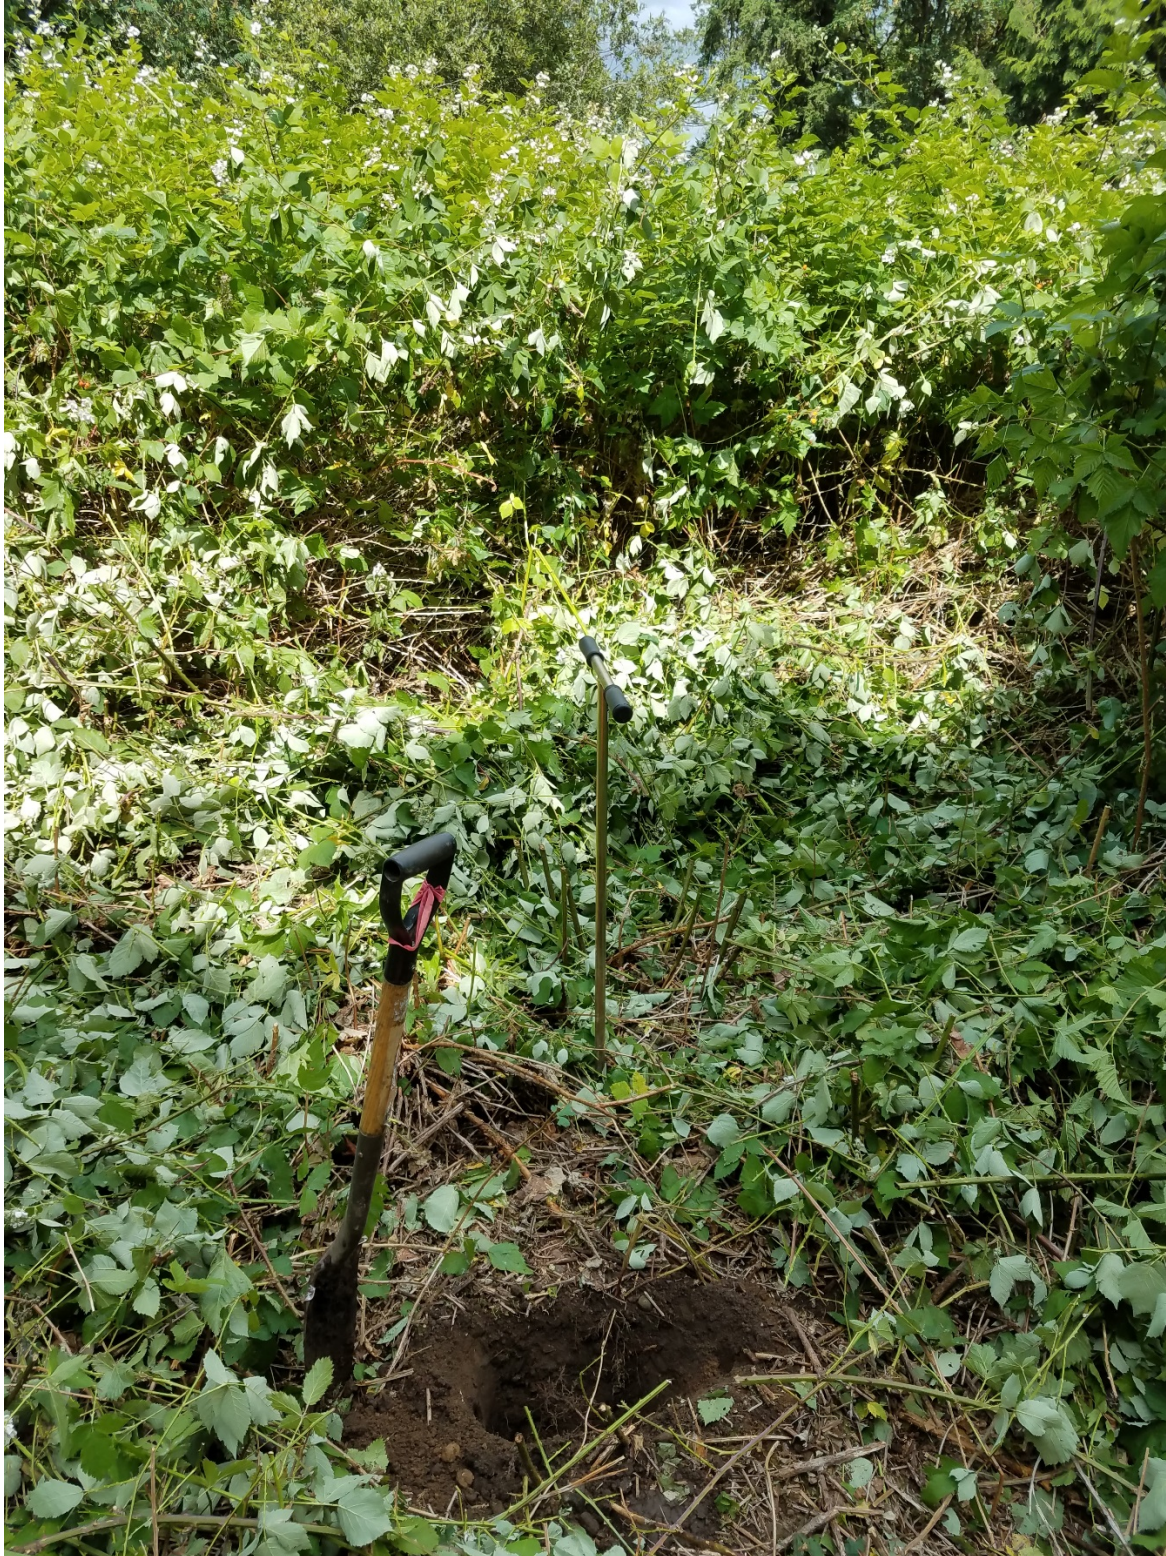
**Photo 11.** Sample Point TP-UPL-6. Typical vegetation includes Himalayan Blackberry and Salmonberry. Photo date: 22 June 2018.

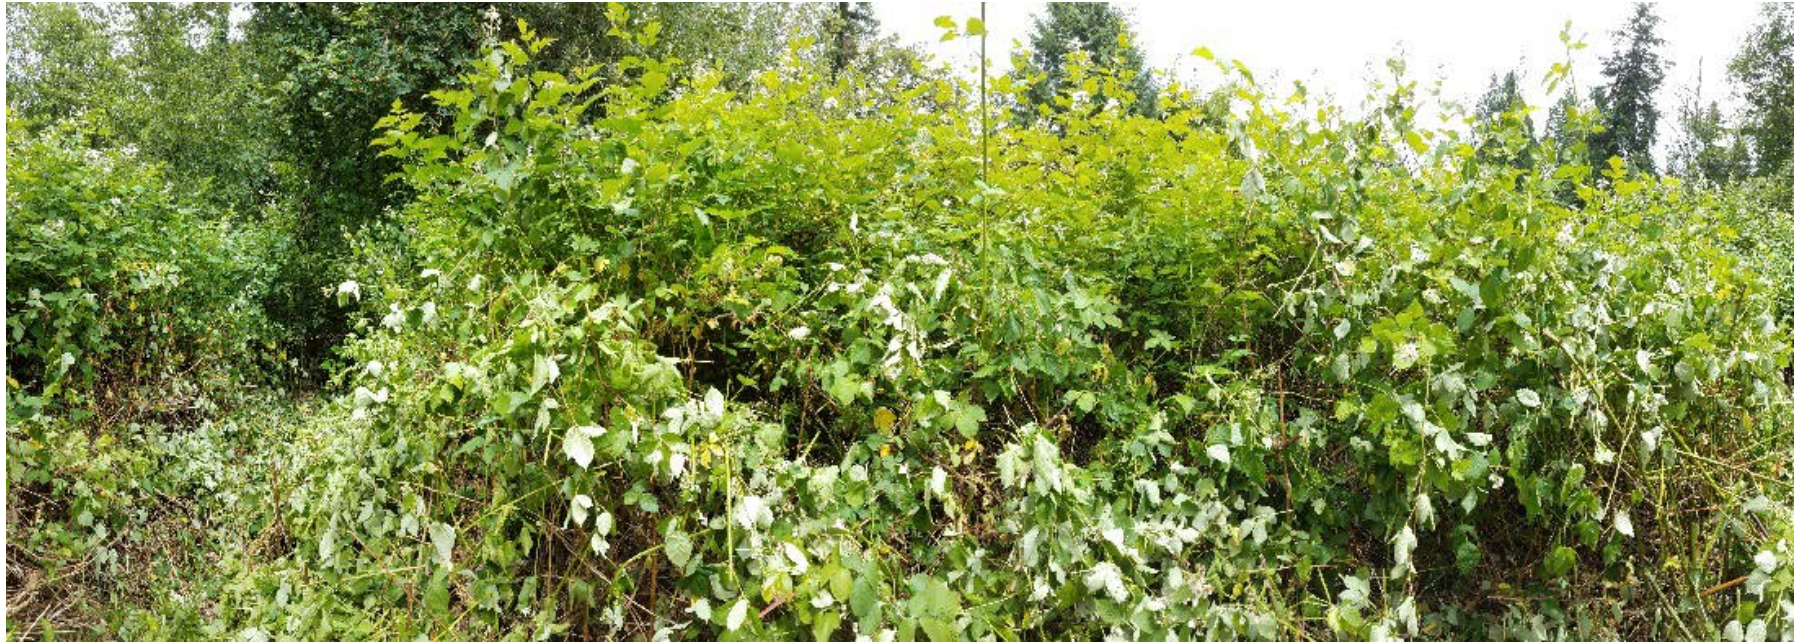
**Photo 12.** Panorama of Sample Point TP-UPL-6. Vegetation includes Himalayan blackberry, salmonberry, and pink honeysuckle. Photo date: 22 June 2018.
